Huddersfield Geology Group

Local Field Trip Guide – Spring Watch

Netherthong and the surrounding area have many examples of how water has been exploited, from natural springs to manmade irrigation. The Spring Watch field trip takes you to 8 locations, over about 3 miles, exhibiting a range of water supplies. The aim is to try and explain the origin of the water supply and link it, wherever possible, to the underlying geology and other natural features.

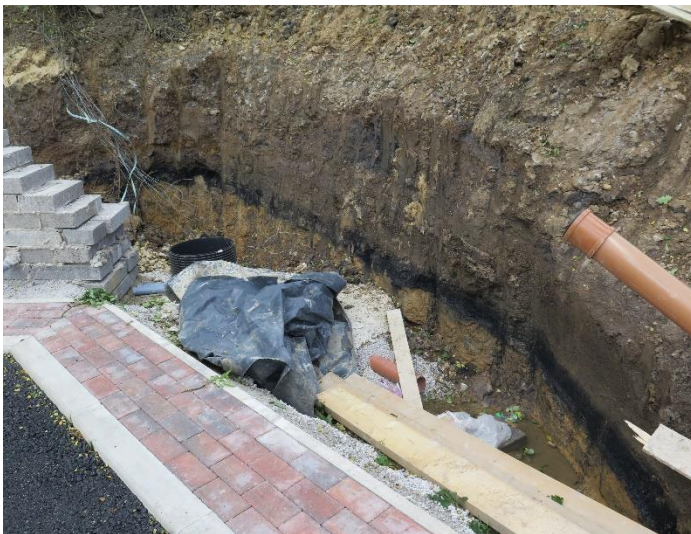
This is Location 1. Grid reference: SE135098. It is at the entrance to a new housing estate (2019) reached by turning right after going westwards out of St Mary's Road and walking uphill (on Miry Lane) for approximately 50 metres.

This picture shows the now concealed coal seam, taken when the facing wall was being constructed (July 2020). Prior to development there was no sign of a spring at this location. When the overburden and some rock was removed to create the access road, a spring appeared. The initial flow was substantial, and an external land drain was put in place, taking water back underground to a new main drain under the road. Since then, a facing wall has been constructed. The spring is just above the Upper Meltham Coal Measure (UMCM). The spring here is at the same level as several active and dormant springs in back gardens within the St Mary's Estate, which are also likely to be due to the same underlying geological conditions.

This spring and those in the St Marys Estate lie on, or close to, the Upper Meltham Coal Measure, between the Huddersfield White Rock and Rossendale Formations. Differences in permeability and the presence of the coal seam are probable causes of these springs. There is a zone of groundwater catchment up-slope of the springs. There is also evidence here of poorly sorted matrix above the 'coal' which is indicative of slumping (probably again due to slippage of soft clay/silt matrix as it gets saturated above the spring line).

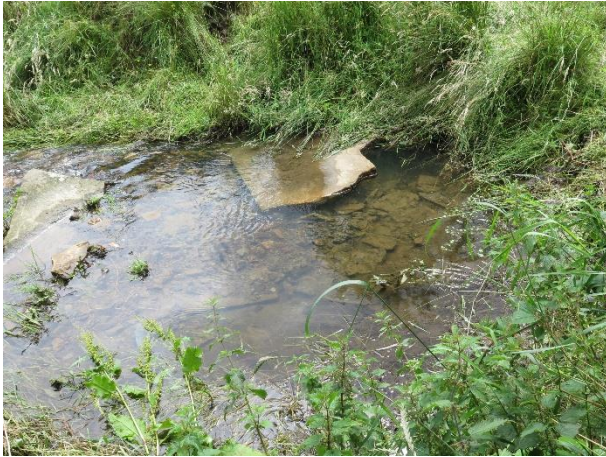
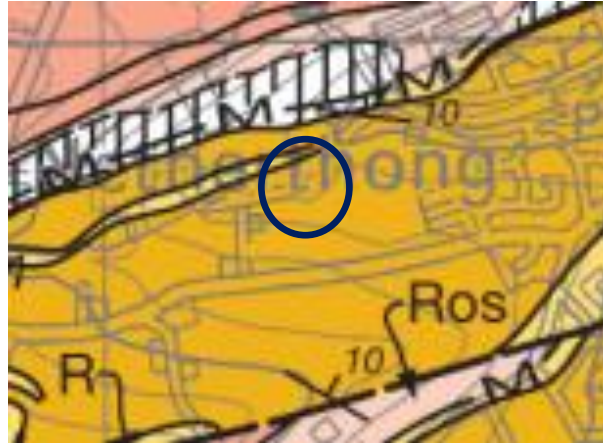
This is Location 2. Grid reference: SE133096. The stream appears to originate in a free-flowing spring, surrounded by slabs of sandstone.

Flooding and footpath erosion have shown that the bedrock close to the stream is only about 30 cm below the path in places. The valley base and side are entirely within the Huddersfield White Rock. The source of the spring is therefore likely to be where the water table comes to the surface at the valley floor. Water in the overburden, and possibly in the flanking Huddersfield White Rock, then emerges. The spring seems to originate at a single point so it may be controlled by localised jointing or fracturing. However, there are no obvious faults or unit boundaries on the map, so the intersection with the water table is probably the primary reason for the spring.

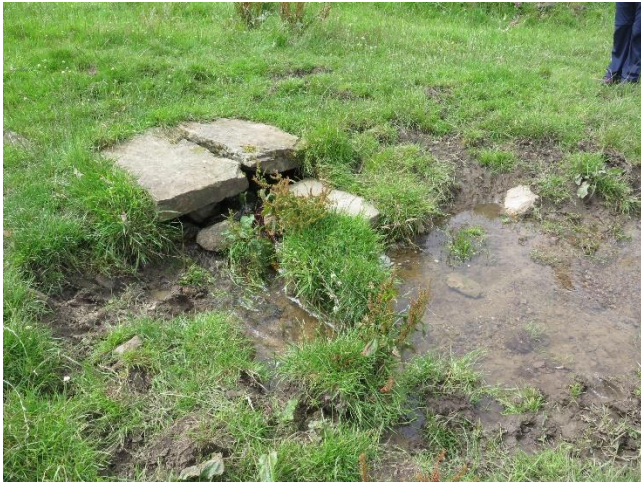
This is Location 3. Grid reference: SE129095. Water emerges from beneath two large stone flags. The water may be fed by a land drain but there is no evidence for a man-made feed.

Field drains are common in the area. The source of this water is likely to be a field drain, tapping into water in the overburden in the fields above the bed of the valley. It has not eroded down to the stream below and its flow may therefore be intermittent. However, it may also be a local exposure of where the water table meets the surface. The overburden in the bed of the valley is very thin, such as at Location 2. Here, it is likely to be much thicker.

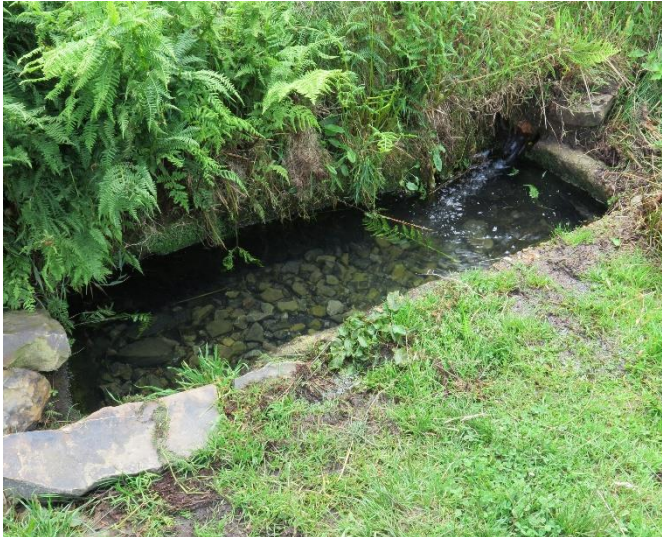
Location 4 is a land drain feeding a large trough. Grid reference: SE126088.

There is a land drain feeding the trough at the back right hand corner. However, the source of water for the drain is unknown. The location is down-slope from a series of complex faults to the north and north west, and close to the boundary between the Rossendale and White Rock formations. This faulting, combined with the position in the foot of the valley, could all contribute to the reliable water supply that has justified a trough of this size.

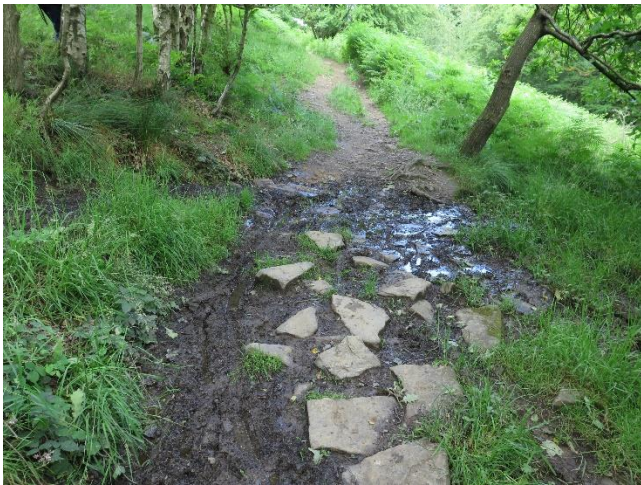
Welcome to Location 5. Grid reference: SE136088. It is a seepage adjacent to the path, with no additional features such as troughs or drains. Note the variable flow has not been sufficient to erode a channel to join the main stream and has instead spread out to give a wide area of marshy ground. There are another 2 springs just to the west of the one pictured that shows signs that attempts have been made to channel the water. See if you can find them!

This location is in a valley bottom, on the Huddersfield White Rock. Note that the Huddersfield White Rock is exposed in the bed of the stream, just below the spring. Therefore, the water source is probably where the water table intersects the valley side, rather than permeating through the Huddersfield White Rock. The water takes the line of least resistance, emerging as a spring.

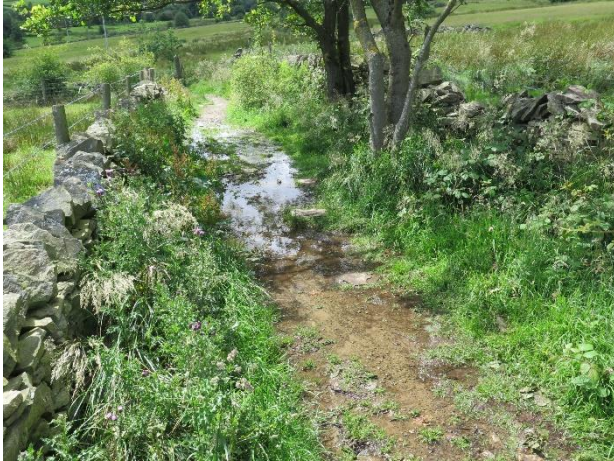
Continue to Location 6. Grid reference: SE136090. It is a flooded section of path, though the flooding stops after a few days without rain.

After heavy rain, you will see copious amounts of water running from the fields to your north. Note the abrupt change in vegetation in the field and those to the west, with distinct patches of a type of rush called *Juncus conglomeratus*. This plant thrives in damp fields and ditches, indicating that the ground retains water even after rainfall has ceased. The likely water source for the spring is where the water table comes to the surface by the path, and above the change in ground angle to the south. (The 1854 map shows a line of ‘troughs’ along this change in vegetation.)

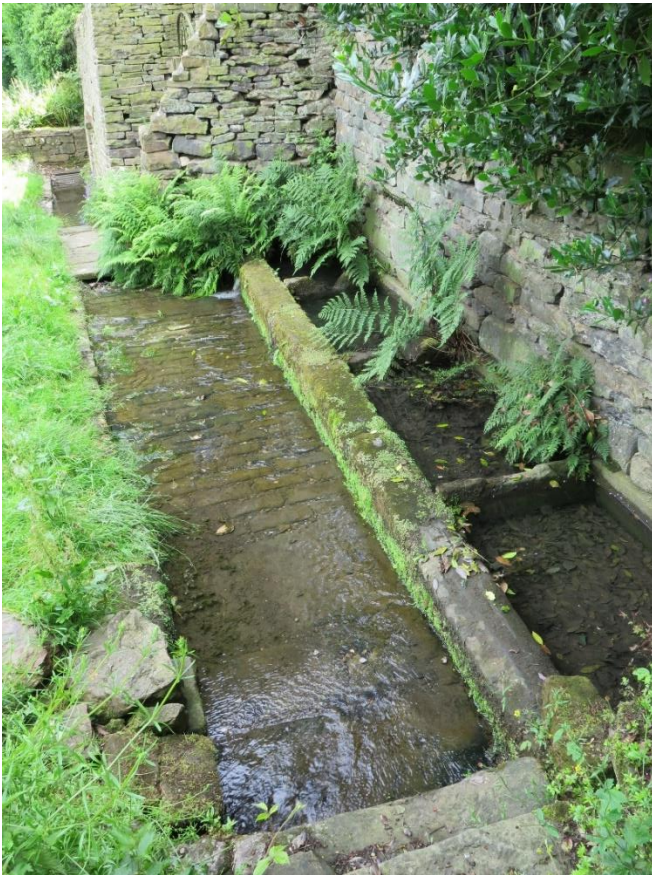
This is Location 7. Grid reference: SE139094. It's a series of troughs, with a cobbled area to the front, and stone steps leading down from the top right.

It is likely that the water supply is very reliable, if not constant, to justify building this structure. The underlying geology here is more complex. There is faulting between the Huddersfield White Rock, Rossendale Formation and the Marsden Formation, another mudstone and siltstone. Faulting has possibly created a path for water to flow from the Huddersfield White Rock, through the less permeable mudstones and out to the troughs.

It is possible that these troughs were used for cleaning fleeces or cloth (and beating on the cobbles in front) before hanging on tenter hooks (the 1854 map shows adjacent tenter fields). Note also the V-notches between the troughs (rather than shallower divides seen on some other troughs).

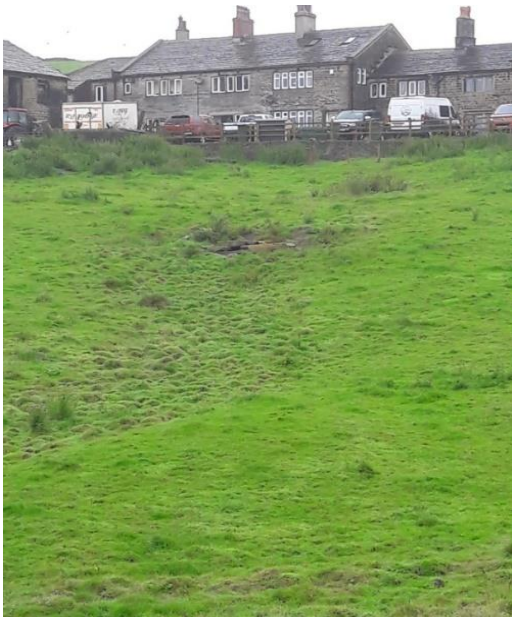
This Location lies further out from the circular walk. You may wish to visit the location on the way to or from Netherthong, although it can be viewed only at a distance. It is a land drain feeding a trough, frequently visited by sheep and cows. Grid reference: SE146105.

In this case, the water trough is very close to a fault line between the Huddersfield Rough Rock and the Rossendale formation. The fault and changes in rock type (and associated permeability) are possible sources of water to feed the land drain.
