Huddersfield Geology Group

Local Field Trip Guide – Spring Watch

Netherthong and the surrounding area have many examples of how water has been exploited, from natural springs to manmade irrigation. The Spring Watch field trip takes you to 8 locations, over about 3 miles, exhibiting a range of water supplies. The aim is to try and explain the origin of the water supply and link it, wherever possible, to the underlying geology and other natural features.

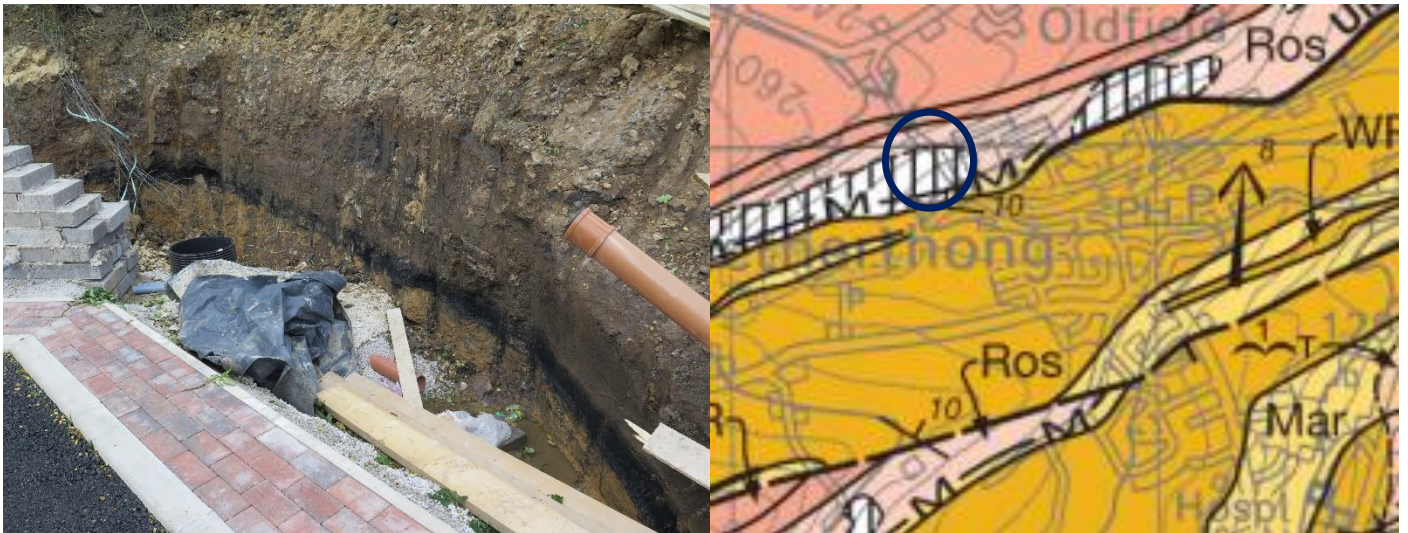
This picture shows the now concealed coal seam, taken when the facing wall was being constructed (July 2020). Prior to development there was no sign of a spring at this location. When the overburden and some rock was removed to create the access road, a spring appeared. The initial flow was substantial, and an external land drain was put in place, taking water back underground to a new main drain under the road. Since then, a facing wall has been constructed. The spring is just above the Upper Meltham Coal Measure (UMCM). The spring here is at the same level as several active and dormant springs in back gardens within the St Mary's Estate, which are also likely to be due to the same underlying geological conditions.

This spring and those in the St Marys Estate lie on, or close to, the Upper Meltham Coal Measure, between the Huddersfield White Rock and Rossendale Formations. Differences in permeability and the presence of the coal seam are probable causes of these springs. There is a zone of groundwater catchment up-slope of the springs. There is also evidence here of poorly sorted matrix above the 'coal' which is indicative of slumping (probably again due to slippage of soft clay/silt matrix as it gets saturated above the spring line).

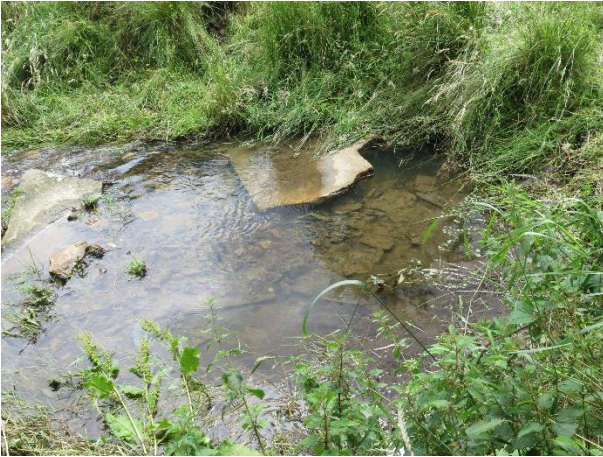
This is Location 2. Grid reference: SE133096. w3w: ///drank.rabble.proud. The stream appears to originate in a free-flowing spring, surrounded by slabs of sandstone.

Flooding and footpath erosion have shown that the bedrock close to the stream is only about 30 cm below the path in places. The valley base and side are entirely within the Huddersfield White Rock. The source of the spring is therefore likely to be where the water table comes to the surface at the valley floor. Water in the overburden, and possibly in the flanking Huddersfield White Rock, then emerges. The spring seems to originate at a single point so it may be controlled by localised jointing or fracturing. However, there are no obvious faults or unit boundaries on the map, so the intersection with the water table is probably the primary reason for the spring.

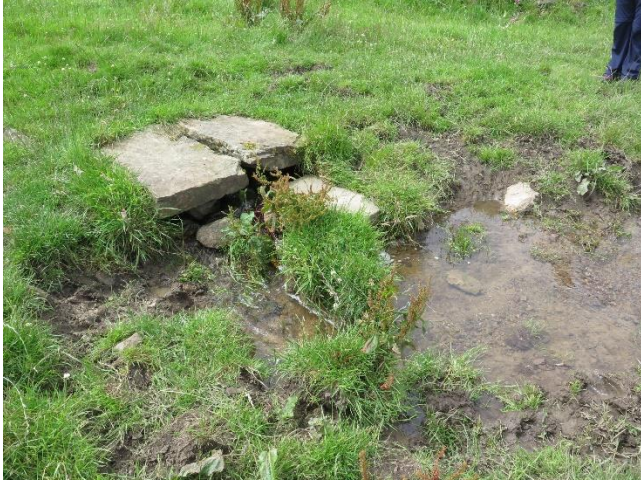
This is Location 3. Grid reference: SE129095. w3w: ///rifled.openly.goods. Water emerges from beneath two large stone flags. The water may be fed by a land drain but there is no evidence for a man-made feed.

Field drains are common in the area. The source of this water is likely to be a field drain, tapping into water in the overburden in the fields above the bed of the valley. It has not eroded down to the stream below and its flow may therefore be intermittent. However, it may also be a local exposure of where the water table meets the surface. The overburden in the bed of the valley is very thin, such as at Location 2. Here, it is likely to be much thicker.

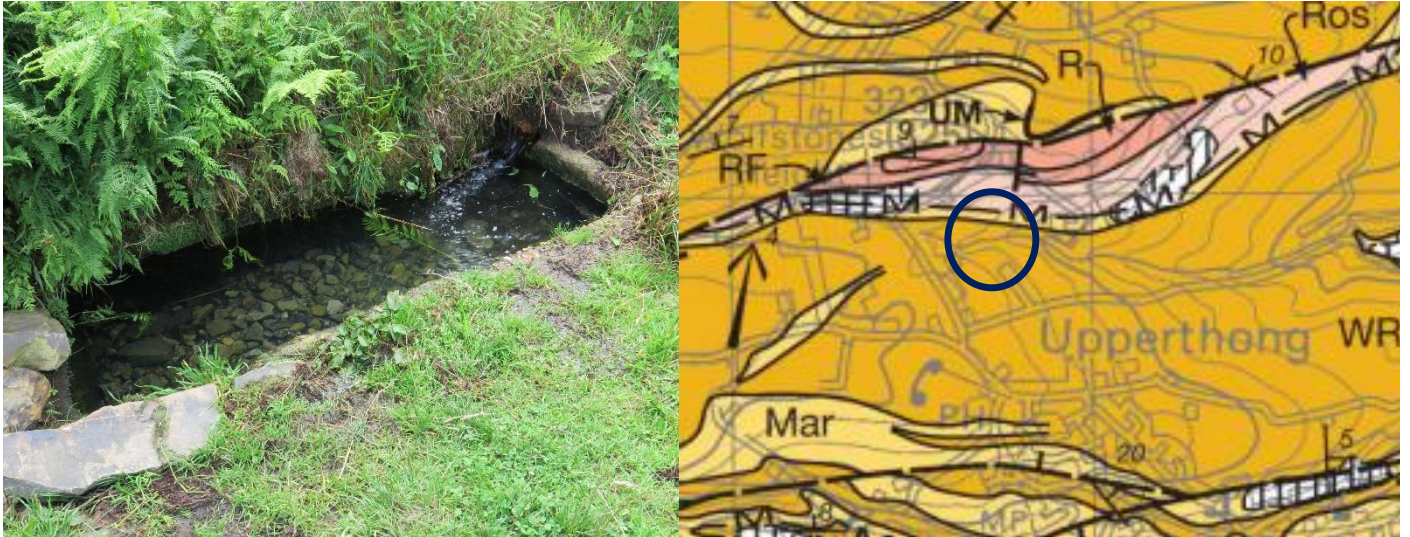
Location 4 is a land drain feeding a large trough. Grid reference: SE126088. w3w: [///crusted.sourcing.freshest.](#)

There is a land drain feeding the trough at the back right hand corner. However, the source of water for the drain is unknown. The location is down-slope from a series of complex faults to the north and north west, and close to the boundary between the Rossendale and White Rock formations. This faulting, combined with the position in the foot of the valley, could all contribute to the reliable water supply that has justified a trough of this size.

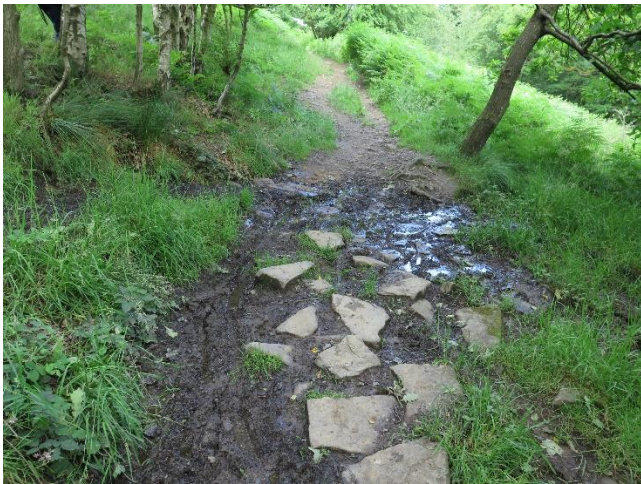
Welcome to Location 5. Grid reference: SE136088. w3w: [///earful.corkscrew.bedroom](https://www.what3words.com/earful.corkscrew.bedroom). It is a seepage adjacent to the path, with no additional features such as troughs or drains. Note the variable flow has not been sufficient to erode a channel to join the main stream and has instead spread out to give a wide area of marshy ground. There are another two springs just to the west of the one pictured that shows signs that attempts have been made to channel the water. See if you can find them!

This location is in a valley bottom, on the Huddersfield White Rock. Note that the Huddersfield White Rock is exposed in the bed of the stream, just below the spring. Therefore, the water source is probably where the water table intersects the valley side, rather than permeating through the Huddersfield White Rock. The water takes the line of least resistance, emerging as a spring.

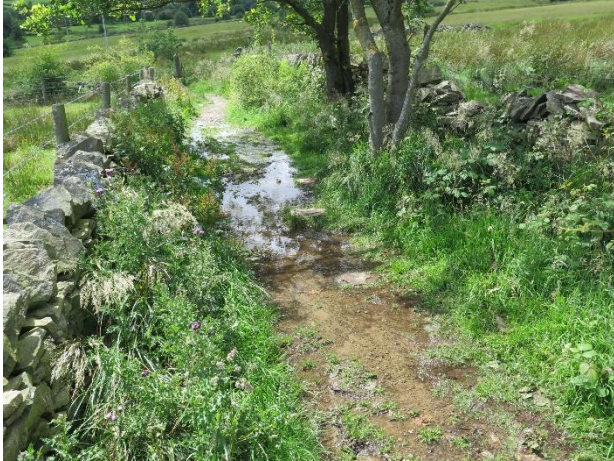
Continue to Location 6. Grid reference: SE136090. w3w: ///somewhere.reassured.water. It is a flooded section of path, though the flooding stops after a few days without rain.

After heavy rain, you will see copious amounts of water running from the fields to your north. Note the abrupt change in vegetation in the field and those to the west, with distinct patches of a type of rush called *Juncus conglomeratus*. This plant thrives in damp fields and ditches, indicating that the ground retains water even after rainfall has ceased. The likely water source for the spring is where the water table comes to the surface by the path, and above the change in ground angle to the south. (The 1854 map shows a line of ‘troughs’ along this change in vegetation.)

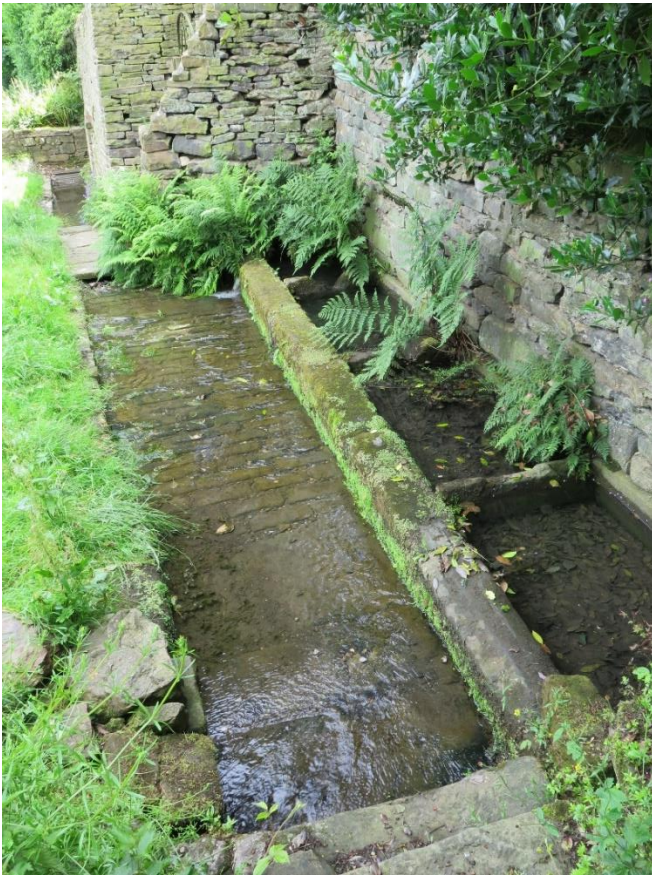
This is Location 7. Grid reference: SE139094. w3w: [///trending.videos.optimally](https://www.trending.videos.optimally.com/SE139094) . It's a series of troughs, with a cobbled area to the front, and stone steps leading down from the top right.

It is likely that the water supply is very reliable, if not constant, to justify building this structure. The underlying geology here is more complex. There is faulting between the Huddersfield White Rock, Rossendale Formation and the Marsden Formation, another mudstone and siltstone. Faulting has possibly created a path for water to flow from the Huddersfield White Rock, through the less permeable mudstones and out to the troughs.

It is possible that these troughs were used for cleaning fleeces or cloth (and beating on the cobbles in front) before hanging on tenter hooks (the 1854 map shows adjacent tenter fields). Note also the V-notches between the troughs (rather than shallower divides seen on some other troughs).

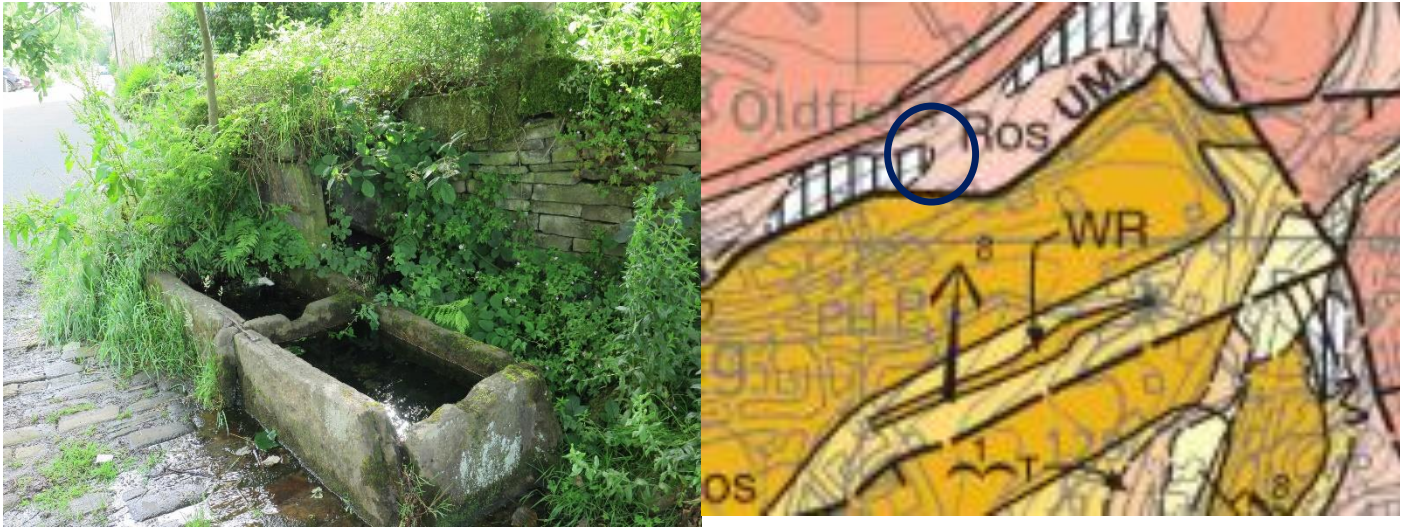
This is Location 8, the final destination on the circular walk. It is on the left as you approach, on the north side of Dean Brook Road, just after a row of cottages. It is a series of troughs, though the feed is obscured behind the rear trough. Grid reference: SE142101. w3w: [///librarian.credit.parade.](https://www.threewords.com/location/SE142101)

Troughs set into walls are common in the area. This is an unusual example, with a large enclosed trough at the rear and two more accessible troughs at the roadside. It is possible that the rear trough was used for human drinking water and the front troughs for animals.

In this example, the water troughs are at the boundary between the Huddersfield White Rock and the Rossendale formation. It also lies on, or very close to, the Upper Meltham Coal Measure. The changes in rock type (and associated permeability) are the probable sources of water to feed these troughs. However, it is also likely that a land drain has been added to exploit the natural spring. The spring is probably permanent, or almost so, to justify building this elaborate set of troughs. The outflow from the troughs pass under the road to the walled stream on the other side. Note the walling to provide confined flow to local mills, now demolished.

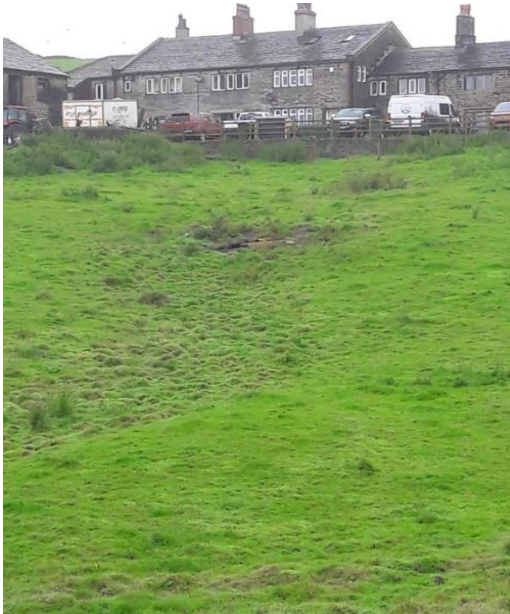
This Location lies further out from the circular walk. You may wish to visit the location on the way to or from Netherthong, although it can be viewed only at a distance. It is a land drain feeding a trough, frequently visited by sheep and cows. Grid reference: SE146105. w3w:///cheese.wonderfully.much (estimated from overhead view).

In this case, the water trough is very close to a fault line between the Huddersfield Rough Rock and the Rossendale formation. The fault and changes in rock type (and associated permeability) are possible sources of water to feed the land drain.
